## TWO CLEANING PROJECTS:

### Building One:

### **Building Two:**

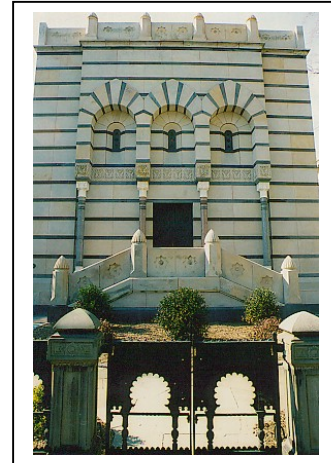
Project: Exterior restoration and repairs to envelope, including cleaning of the façades.  
Location: Scroll and Key, Secret Society, Yale University  
Building: College and Wall Streets, New Haven, CT  
(NY) Built 1868  
Architect: Richard Morris Hunt  
Owner Representative: Leland Torrence Enterprises  
Restoration Consultant: Leland Torrence Enterprises  
Construction Manager: Leland Torrence Enterprises  
GC for Masonry: E&W Construction  
Consultants: Brian Skinner and Jay Agu, Geology and Geophysics, Yale University  
Cleaning Tests: Apple Restoration and Waterproofing  
Craftsmen: The Guild of Fine Craftsmen and Artisans

For this project we had the advantage of having a client that wanted research, testing and was willing to wait for the proper analysis. We started the project as part of an overall survey and analysis of existing conditions both inside and out, and development of a ten-year capital improvement plan with prioritization of the needs and estimated costs for the work. The survey for the exterior restoration was performed six months prior to commencing the restoration. There was also some roof work and various methods of stabilization to allow the building to dry out. The survey included sounding, mapping and photographing of all the exterior masonry. Core samples of both the sandstone and blue stone were taken to determine the extent, type and cause of the deterioration of the surface.

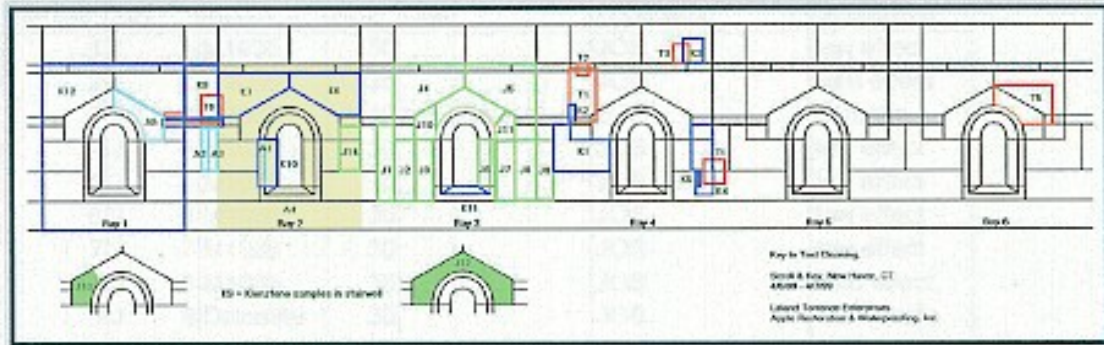
## Graphic Key of Mock-Ups

It is important to note that fairly extensive research was performed prior to the mock ups for cleaning. As the building had been covered with ivy for close to a century, there were numerous factors contributing to the deterioration of the stone. In particular, the sandstone with its varying sizes of aggregate, its extreme porosity, and delicate silica binders proves to be a difficult candidate for cleaning. Some 42 cleaning tests were performed on the building at different times. Ken Follett of Apple Restoration and Waterproofing oversaw and mapped the majority of these tests.

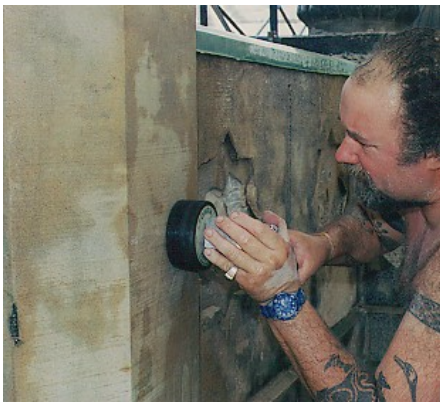
There were four major chemical conditions contributing to the breakdown of the silica binders in the sandstone. However, according to Brian Skinner, Eugene Higgins Professor of Geology and Geophysics at Yale University, they all pale in significance to the accelerated deterioration caused by the pitted surfaces that exponentially increase the water absorption of the stone. The original ashlar surface of the stone allowed for good

repellency of water. A clean quartz surface is naturally hydrophobic. The tests showed that the pervasive film of debris was lodged as deep as three average sand grains from the original surface.

The test results on the honed vs degraded surface were dramatic. A drop of 0.5cc of water was dispersed and absorbed instantly on the existing degraded surface while it remained as a coherent drop for more than five minutes on the honed sample. Therefore the decision was made to re-hone the surface of the stone to match its original performance specifications and provide a clean surface. By this method we could protect the greatest percentage of the

original fabric for the longest period of time and return its appearance to the beauty intended by its well known architect Richard Morris Hunt. . The work was performed by E& W Construction and Gothic Stone Restoration with members of The Guild of Fine Craftsmen and Artisans.
